# BIGLIS TO DINAS POWYS ATR

## Water Vole and Otter Survey Report

NOVEMBER 2023

Author Rebecca Howells  
Checker Siân Carr  
Approver Hannah Corcoran  
Document Ref. 10058585-ARC-XX-300-RP-E-00001  
Date NOVEMBER 2023

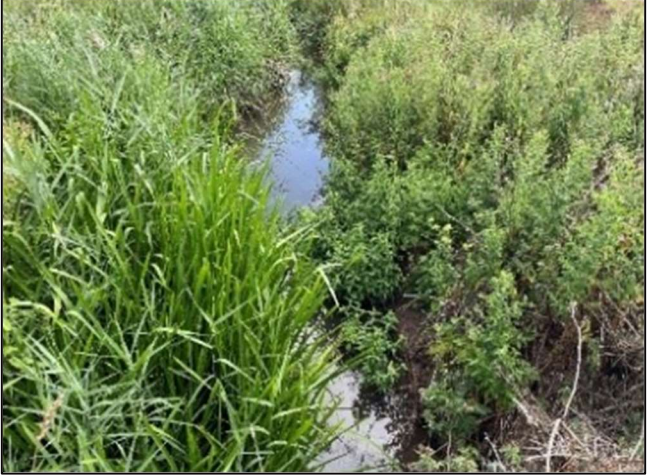
Plate	Description	Photograph
1	Section A – area of dense vegetation during the first survey visit.

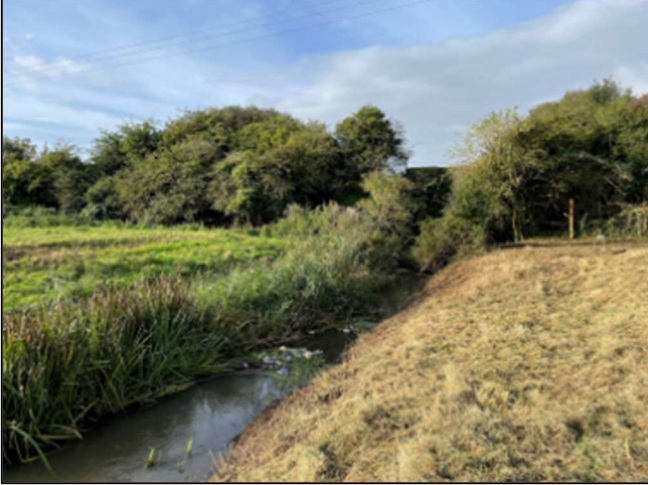
2	Section A – flailed channel bank during the second survey (facing downstream)

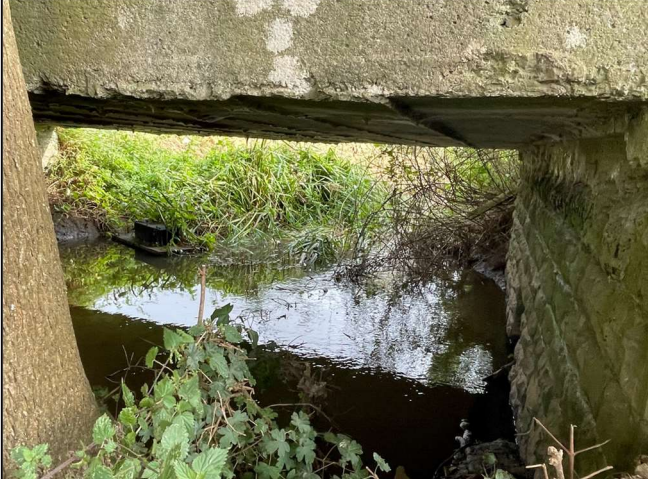
3	Section A – Small bridge spanning the Cadoxton River.

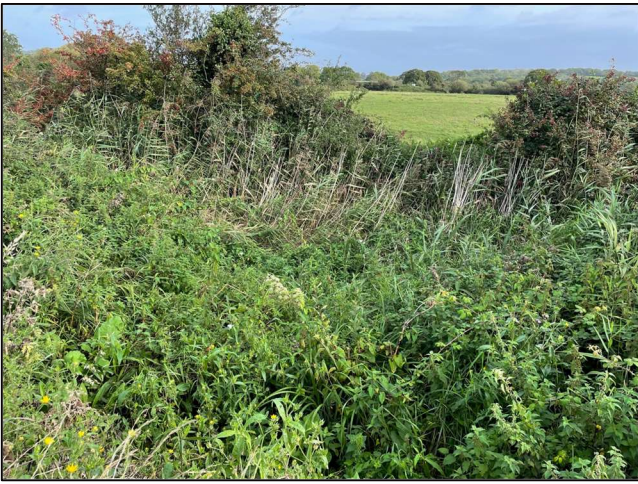
Plate	Description	Photograph
6	Section B	 
7	Section B

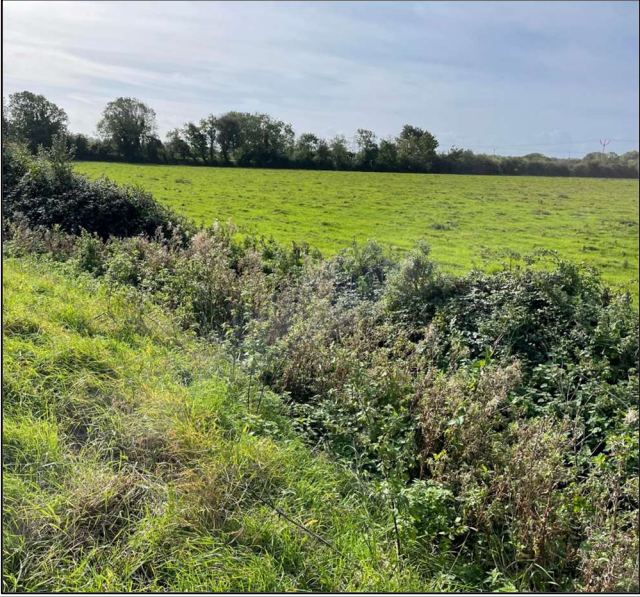
Plate	Description	Photograph
9	Section C

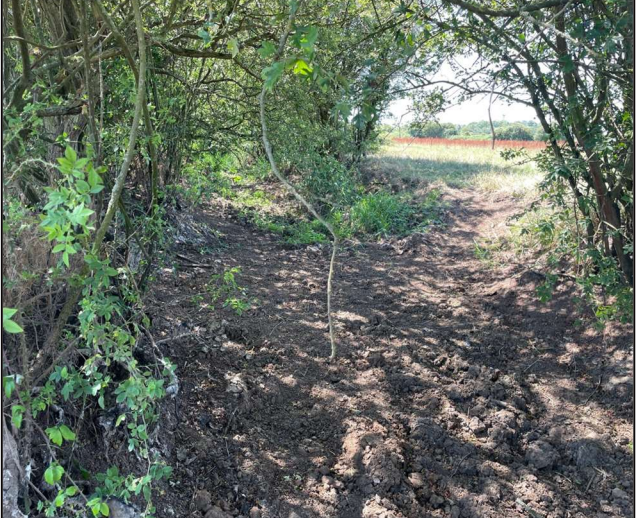
The ditch was dry during the first survey visit and flooded during the second visit. The banks were shallow, and the riparian vegetation consisted of terrestrial grass species, which may indicate that this watercourse only fills during periods of heavy rain.

10	Section D during the first field survey

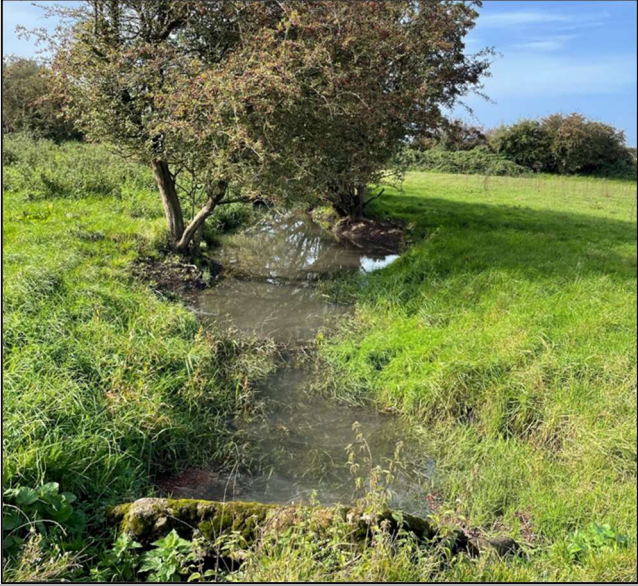
Plate	Description	Photograph
11	Section D during the second field survey

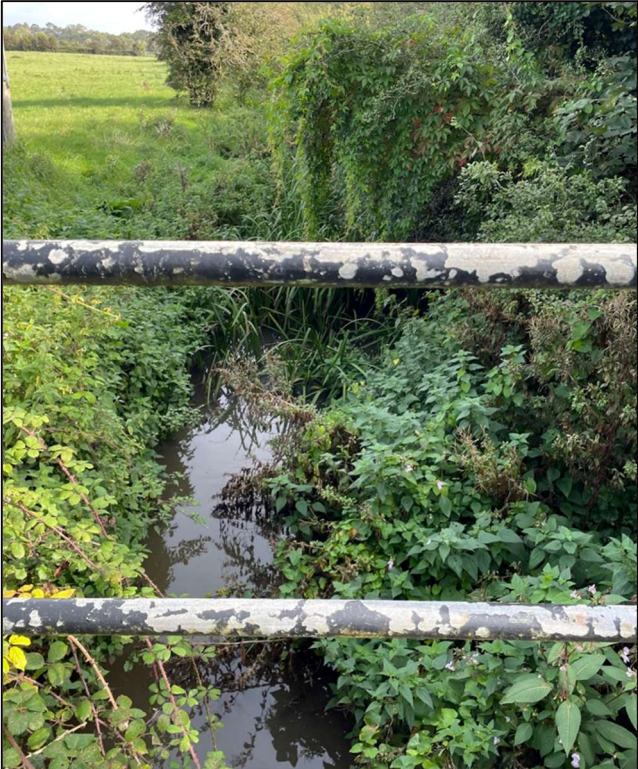
12	Section E – southern stretch of Section E with dense vegetation

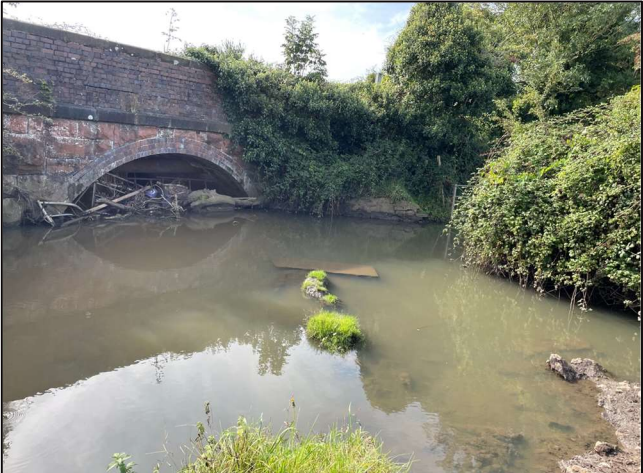
Plate	Description	Photograph
13	Junction between Sections A, C, D and E (north of A4055)

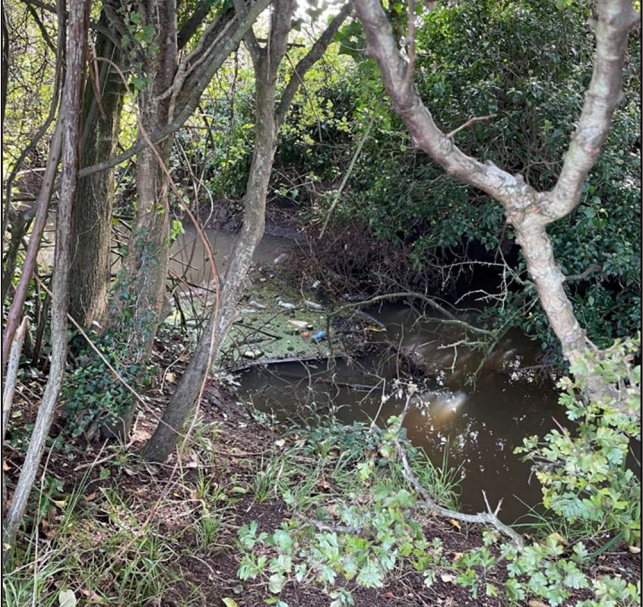
The riparian habitat immediately north of the A4055 road bridge was heavily cattle poached and the underside of the bridge had a build-up of debris.

14	Section E – bare ground and plastic waste along the Cadoxton River.

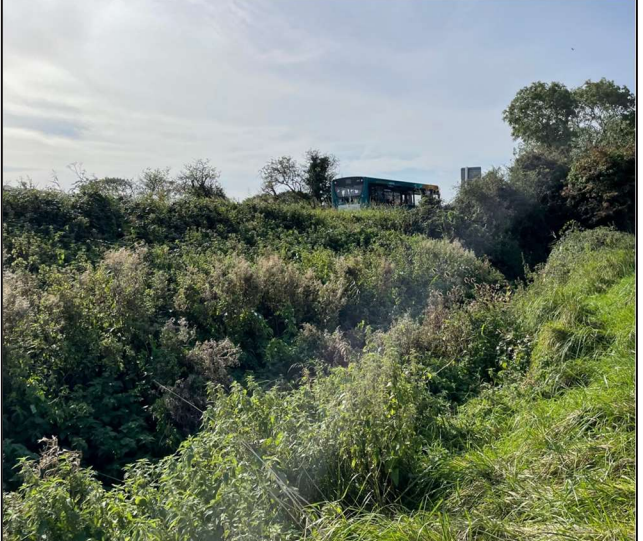
15	Section E – most northern section of the Cadoxton River survey boundary

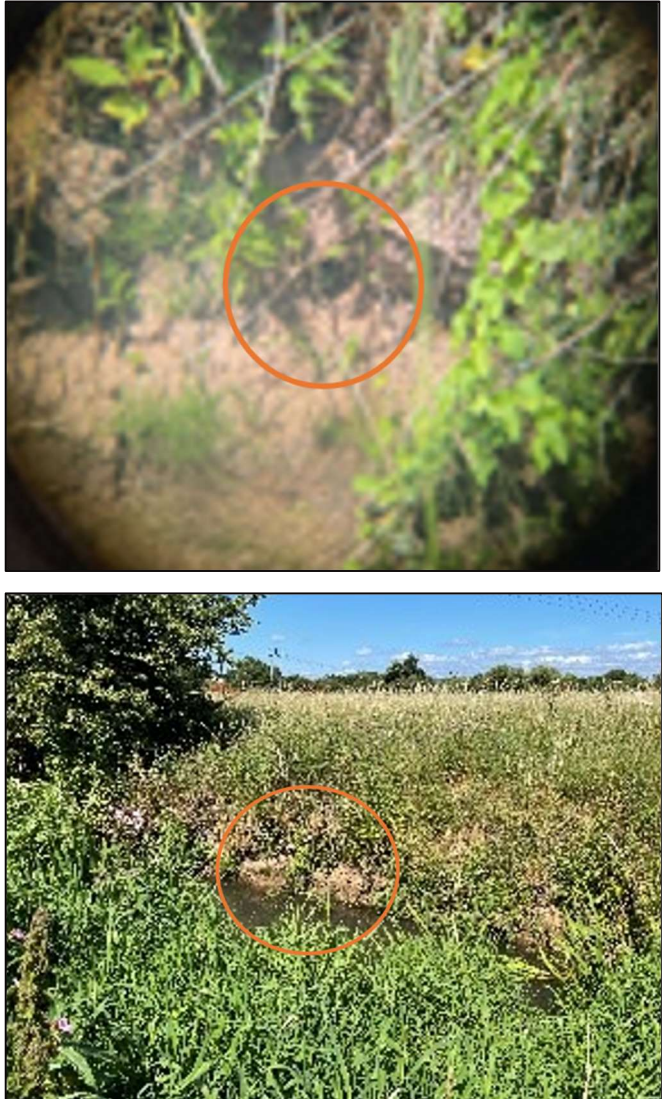
Target note	Description	Grid reference	Photograph
1	Burrows along the channel bank immediately above the water level	ST 14740 69122

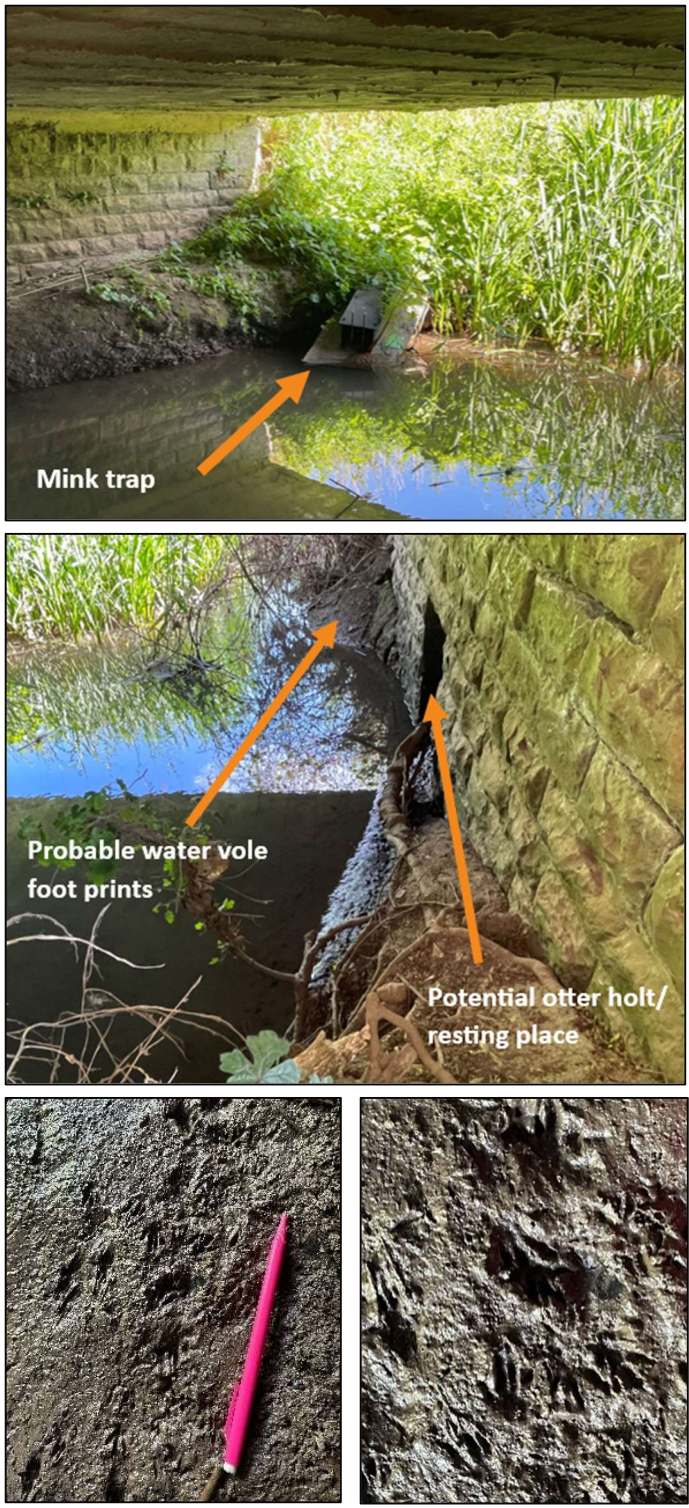
Target note	Description	Grid reference	Photograph
2	<p>-Probable water vole footprints located under bridge.</p> <p>-Mink trap under bridge</p> <p>-potential for resting otter under bridge</p>	ST 14775 69147

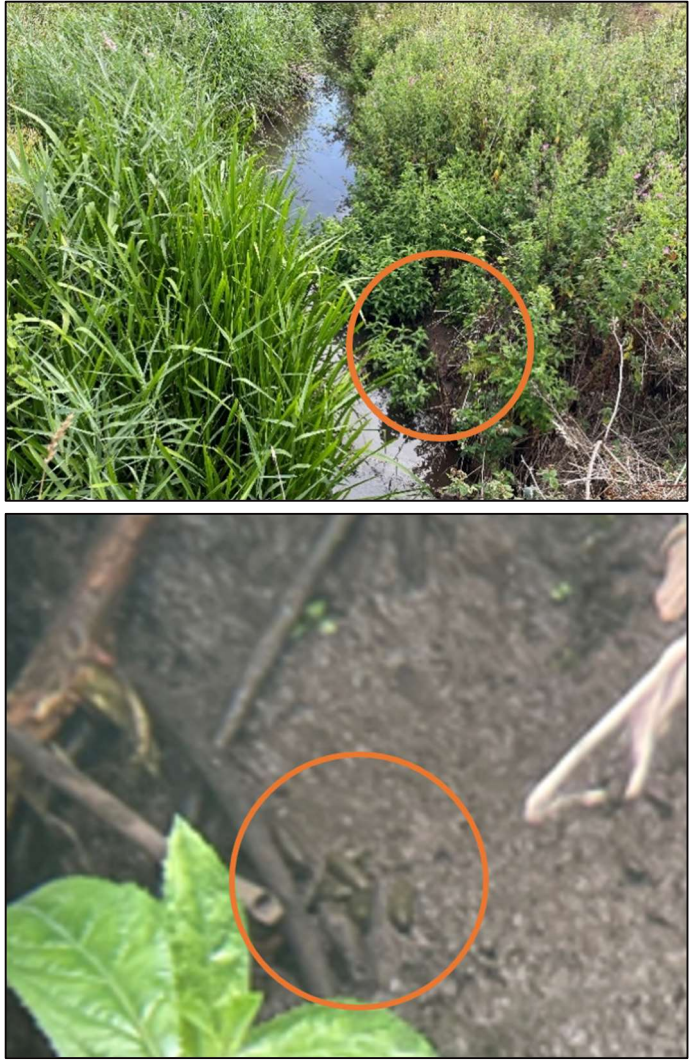
Target note	Description	Grid reference	Photograph
3	Water vole latrine (fresh droppings) located on southern bank	ST 14780 69150

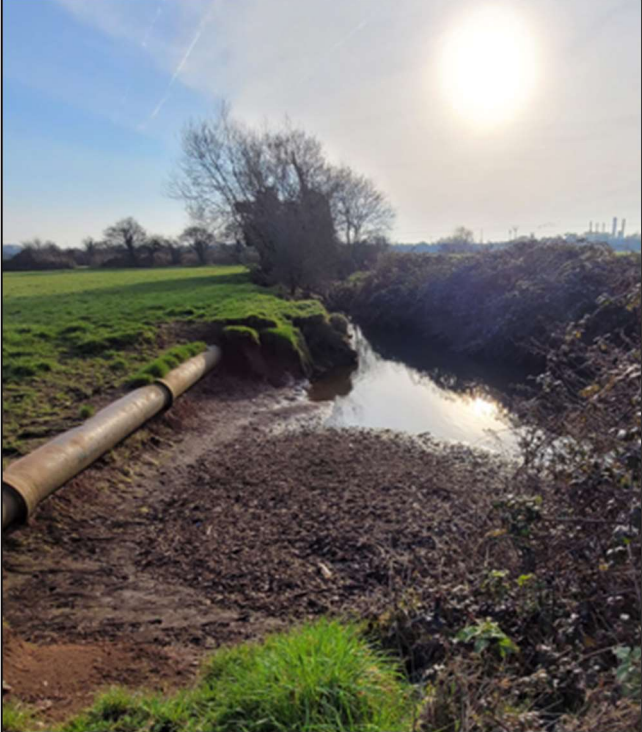
Target note	Description	Grid reference	Photograph
5	<p>Photograph of exposed and cow poached river section between A4055 bridge and water vole signs.</p> <p>Grid references are for additional cattle poached river sections</p>	<p>ST 14890 69302, ST 14880 69325, ST 14983 69444</p>

If possible, cattle access to the wider Cadoxton River banks should be restricted through additional fencing and left to regenerate naturally, to allow safe passage and connect suitable habitat for water vole and otter.

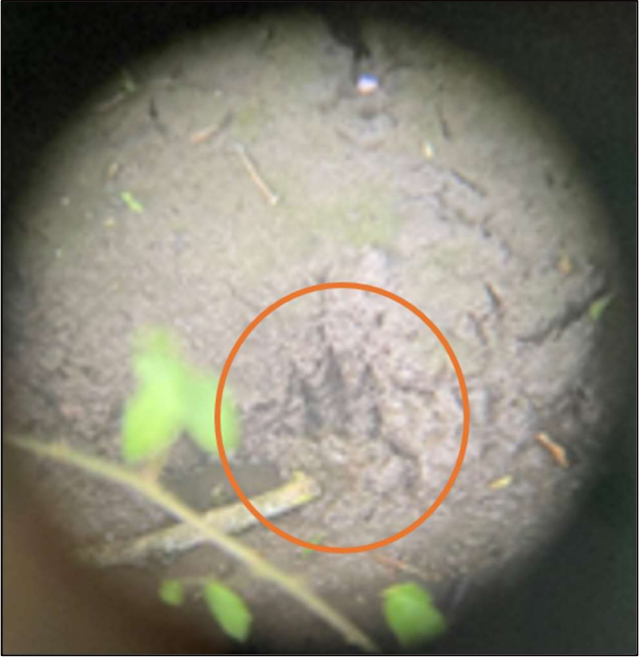
6	<p>Probable otter tracks (west bank, Cold Brook)</p>	<p>ST 14792 69483</p>

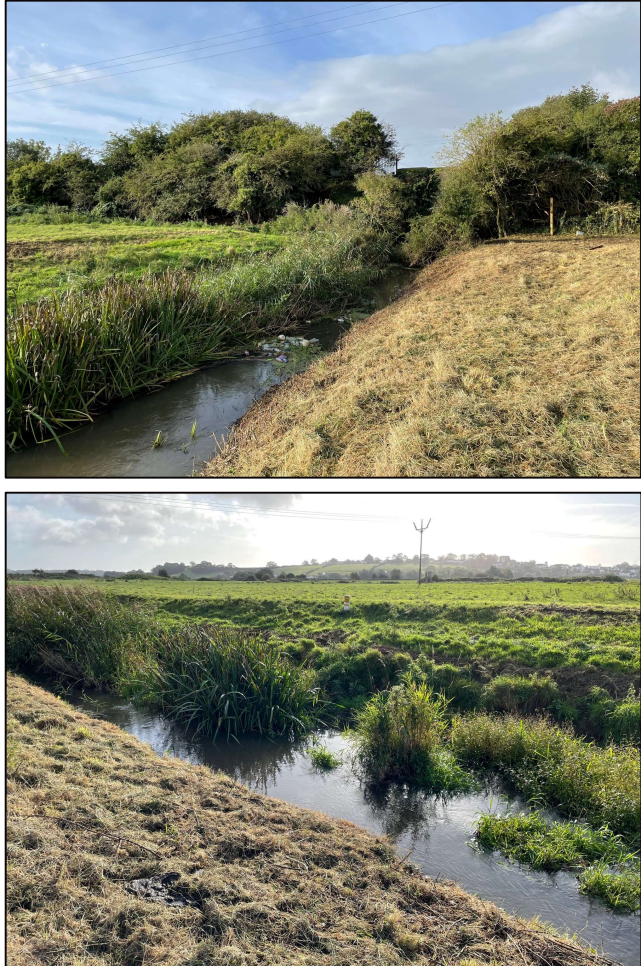
Target note	Description	Grid reference	Photograph
7	Vegetation cut to ground from the waterline at Section A of the Cadoxton River	Between ST 14639 69068 - ST 14884 69304

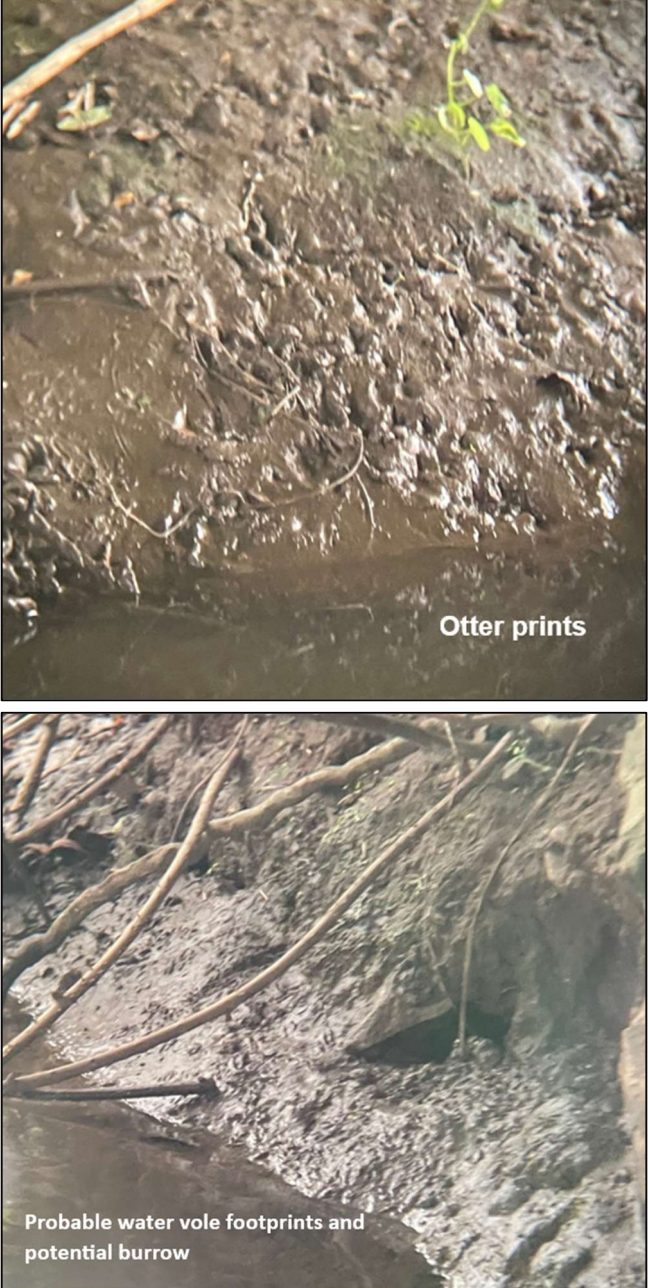
Target note	Description	Grid reference	Photograph
8	Otter and probable water vole foot prints under bridge	ST 14773 69150

<p data-bbox="1093 1003 1246 1037">Otter prints</p> <p data-bbox="676 1603 1023 1659">Probable water vole footprints and potential burrow</p>

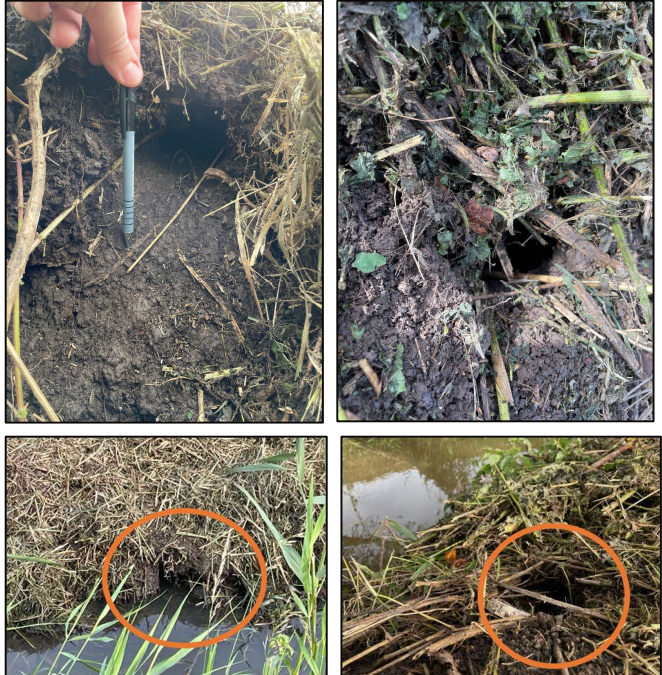
Target note	Description	Grid reference	Photograph
9	Water vole burrows	ST 14788 69156

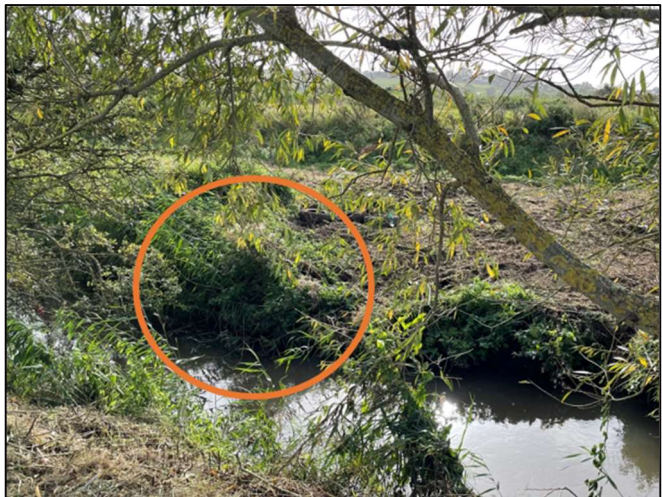
10	Rustling vegetation and 'plop' sound during second survey visit	ST 14803 69174
