# BIGLIS TO DINAS POWYS ATR

## Water Vole and Otter Survey Report

NOVEMBER 2023

Author Rebecca Howells  
Checker Siân Carr  
Approver Hannah Corcoran  
Document Ref. 10058585-ARC-XX-300-RP-E-00001  
Date NOVEMBER 2023

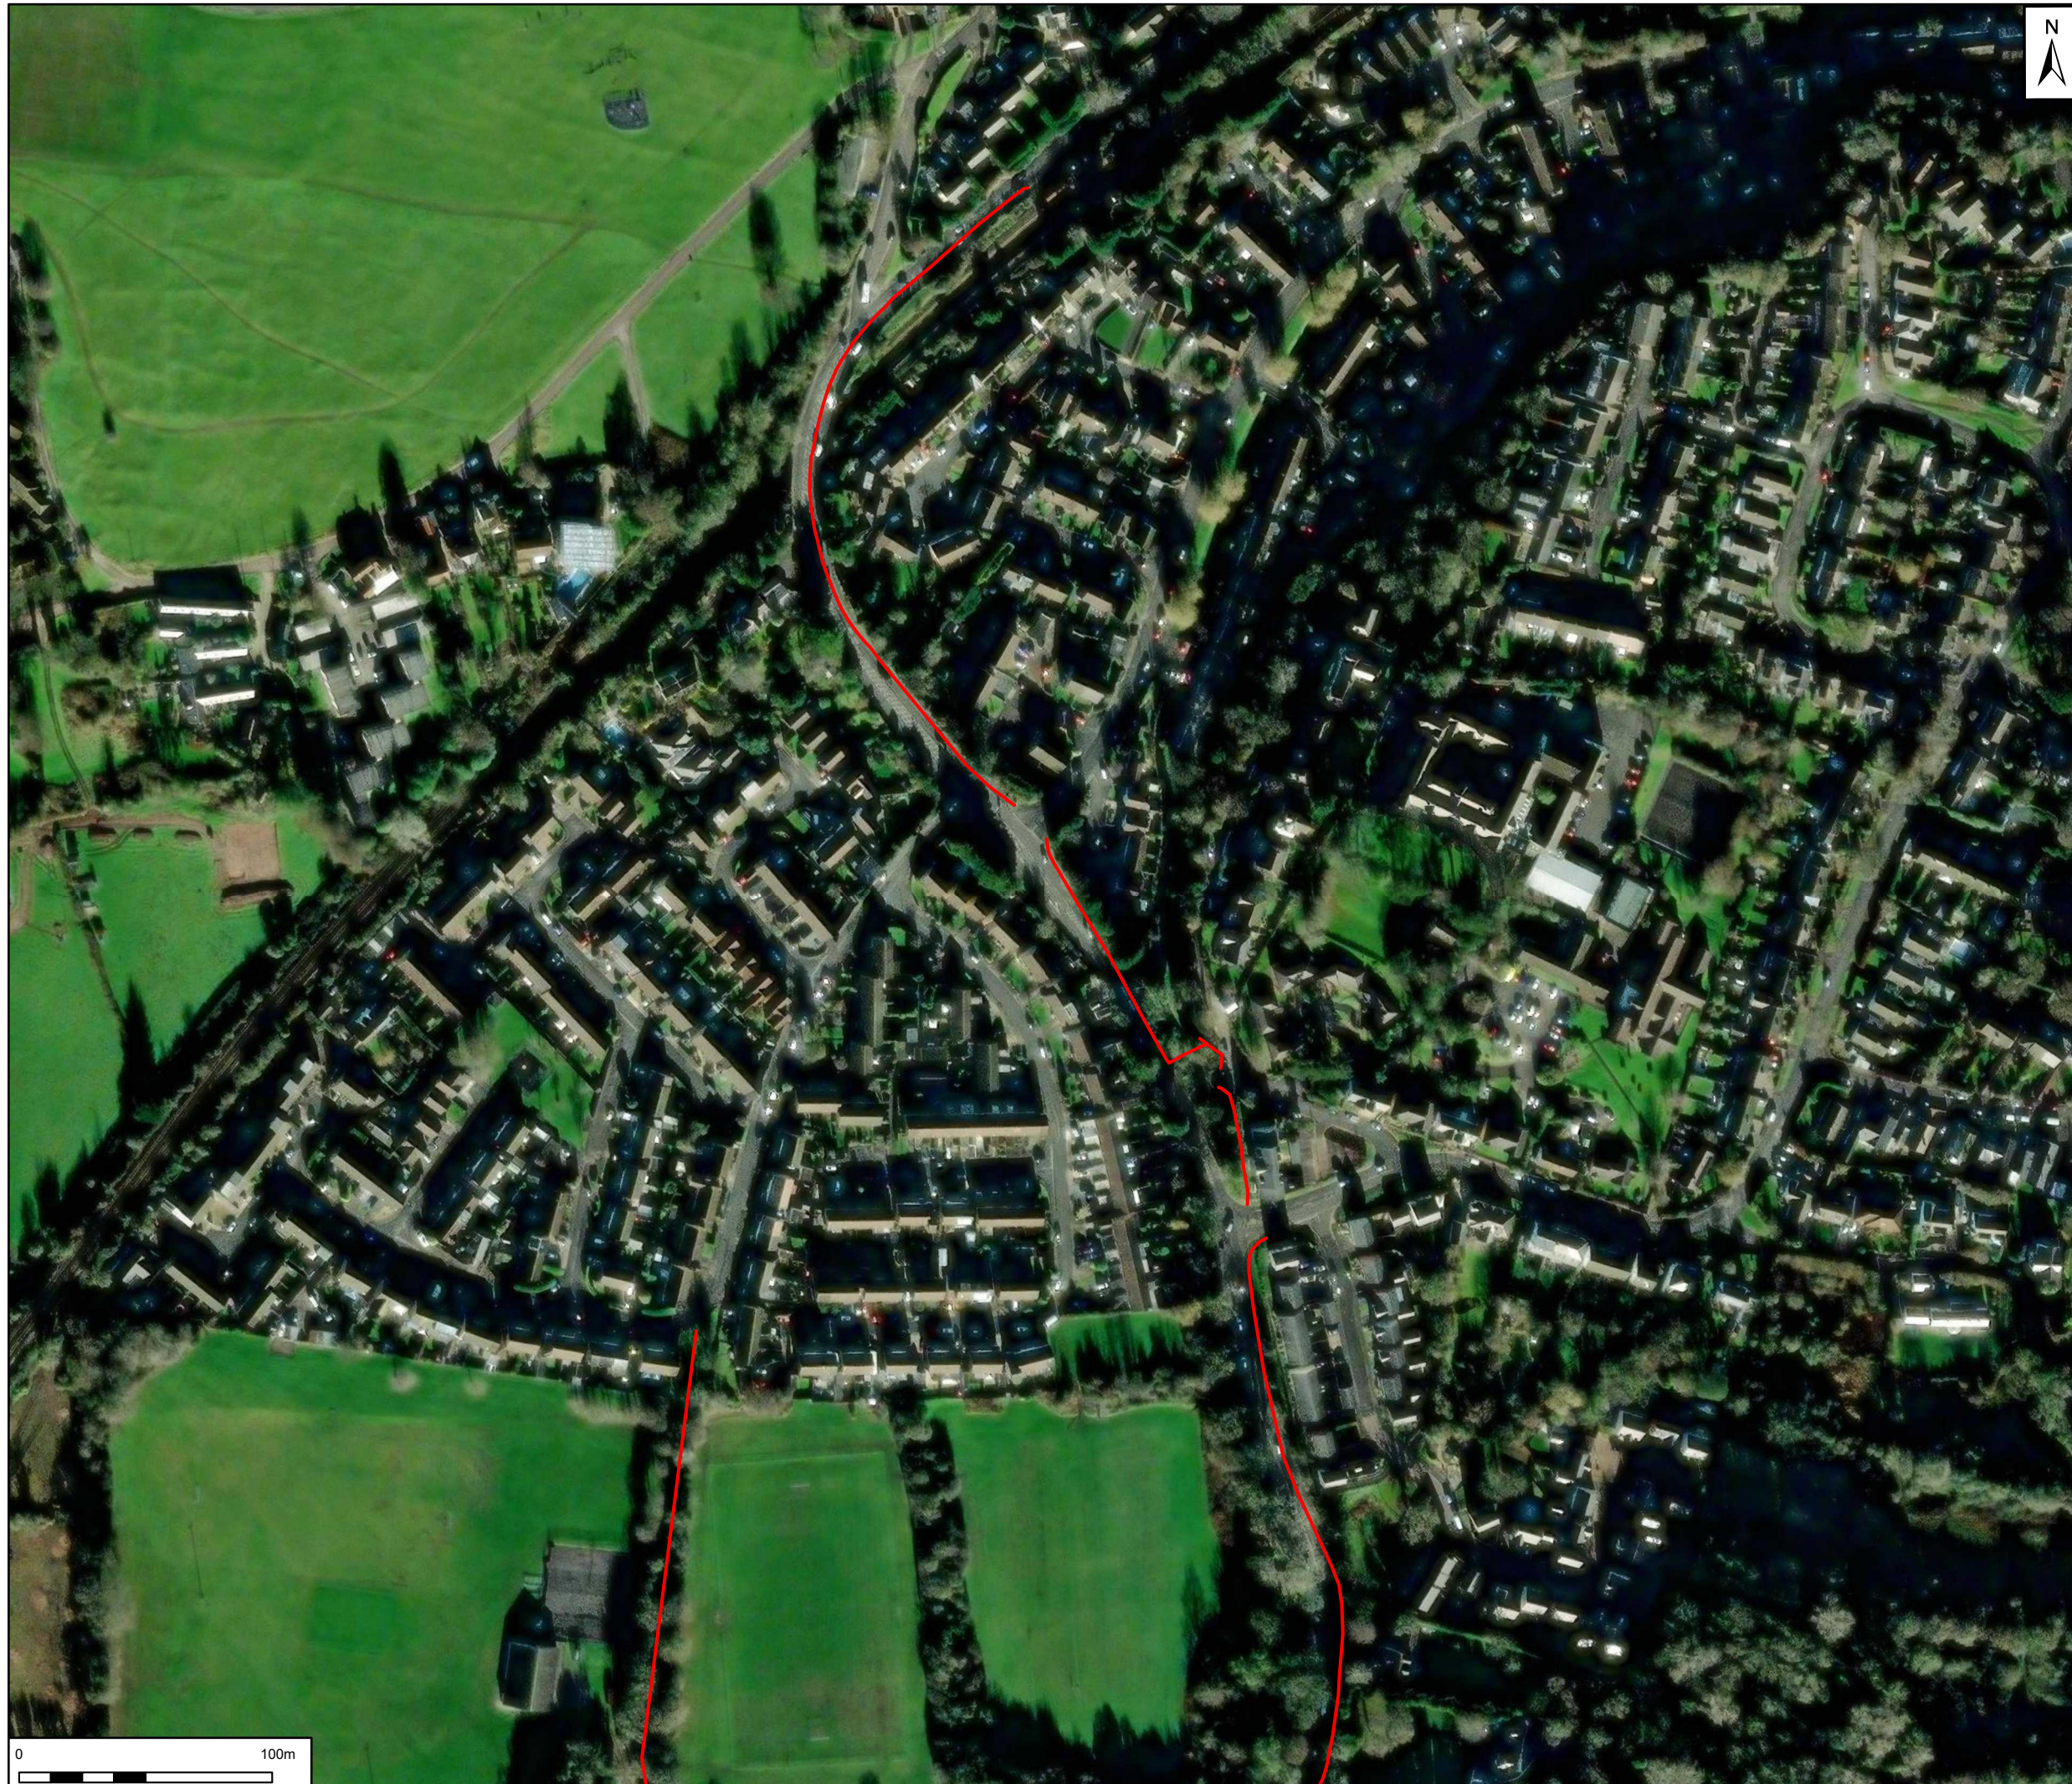
Target note	Description	Grid reference	Photograph
1	Burrows along the channel bank immediately above the water level	ST 14740 69122
